Report No.: HJ-RD-17676-R1

Test Report

Samples for entrusted test in this report were sampled and shipped to test laboratory by applicant on Sept 5th, 2022, packed well and kept in good conditions. Samples were identified as UltraEasy Fence with model number FN 04-1 by the applicant. The dimension of sample is 1880mm×1914.5mm×86mm. Test specimen component shows as follows:

5. **Test Results**

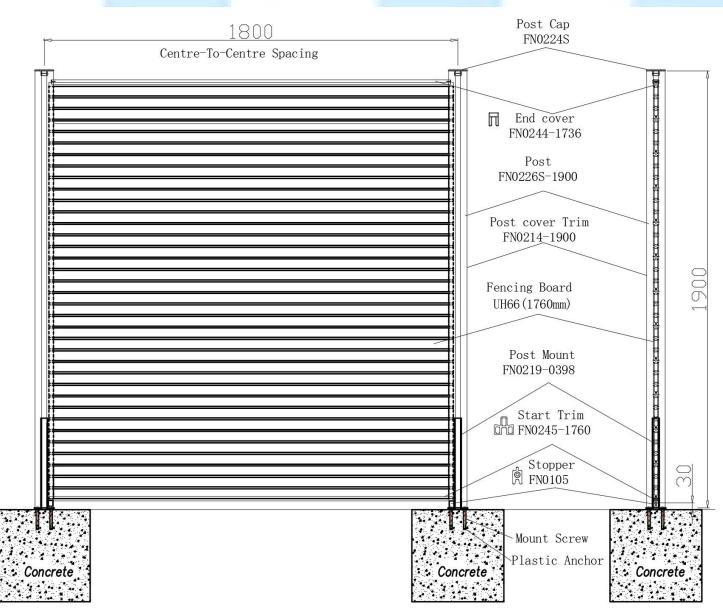
2. **Test Specimen Installation**

BOM				
Description	Code	Length(mm)	Qty	
Post Cap	FN0223R	223R -		
Ending Aluminum Trim	FN0244-1736	1736	1736	
Bracket	FN0220	FN0220 -		
Machine Screw	WJ0128(ST4 x 8)	-	2	
Post Sleeve	FN0213R-2400	2400	2	
Post Trim	FN02214-1900	1900	6	
Fence Board	UH66	1760	12	
Galvanized Steel Tube	W20 x H10	1760	4	
Starting Aluminum Trim	FN0245-1760	1760	1	
Stopper	FN0105	-	2	
Self-Tapping Screw	WJ0127 (ST4 x 20)	-	2

Testing was performed in accordance with Section 11 of ASTM E72-15, Chamber Method. Test specimen was placed the specimen near the floor, which should be practically airtight. An airtight frame or curb shall surround the specimen closely and be about flush with the specimen. A rubber blanket covers the specimen, overlaps the frame, and is sealed so that it is reasonably airtight. Use a small vacuum pump or positiveaction exhaust blower to reduce air pressure between the specimen and floor. Measure the difference in pressure above and below the specimen by means of a manometer.
